MTL-TR 87-50

HYDROGEN INDUCED CRACKS IN ARMOR STEEL WELDMENTS FABRICATED WITH AUSTENITIC FILLER ALLOYS

WILLIAM S. RICCI

September 1987

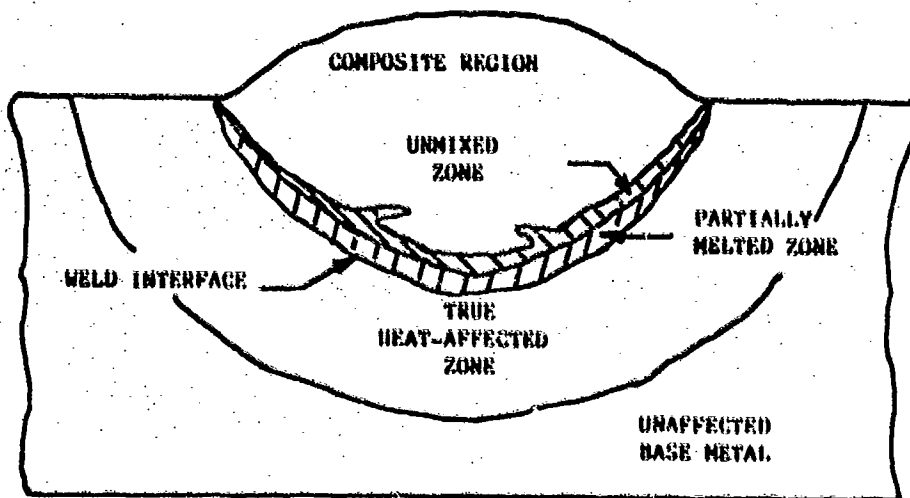
The occurrence of hydrogen induced cracks in the intermediate zone of armor steel weldments fabricated with austenitic electrodes will be discussed in this report. The term "intermediate zone" refers to parts of the composite region of the weld as well as the partially melted zone, the unmixed zone, and the weld interface, as defined by Baeslack et al.³ (Figure 2).

Figure 2. Schematic illustration showing the regions of a heterogeneous weld.
